**WOOD DESTROYING PESTS AND ORGANISMS INSPECTION REPORT**

Building Address: <b>6700 W. 87 th Place, Los Angeles, CA 90045</b>		Date of Inspection 07/16/2013	Number of Pages 6
<b>Dynasty Termite</b> P.O. Box 40898 Downey, CA 90239 P: (323) 726-3330 F: (323) 726-3888		  NAT-92582-1	Report # W12729
			Lic. Registration # PR 6106
			Escrow #
Ordered by: The Real Estate Consultant Deborah Seidel 7151 W Manchester Ave West Chester, CA 90045	Property Owner and/or Party of Interest: The Real Estate Consultant Deborah Seidel 7151 W Manchester Ave West Chester, CA 90045	Report Sent to: The Real Estate Consultant Deborah Seidel 7151 W Manchester Ave West Chester, CA 90045	
COMPLETE REPORT <input checked="" type="checkbox"/> LIMITED REPORT <input type="checkbox"/> SUPPLEMENTAL REPORT <input type="checkbox"/> REINSPECTION REPORT <input type="checkbox"/>			
General Description: Property is a one story wood frame and stucco single family residence with a composition roof and attached garage.		Inspection Tag Posted:    Attic

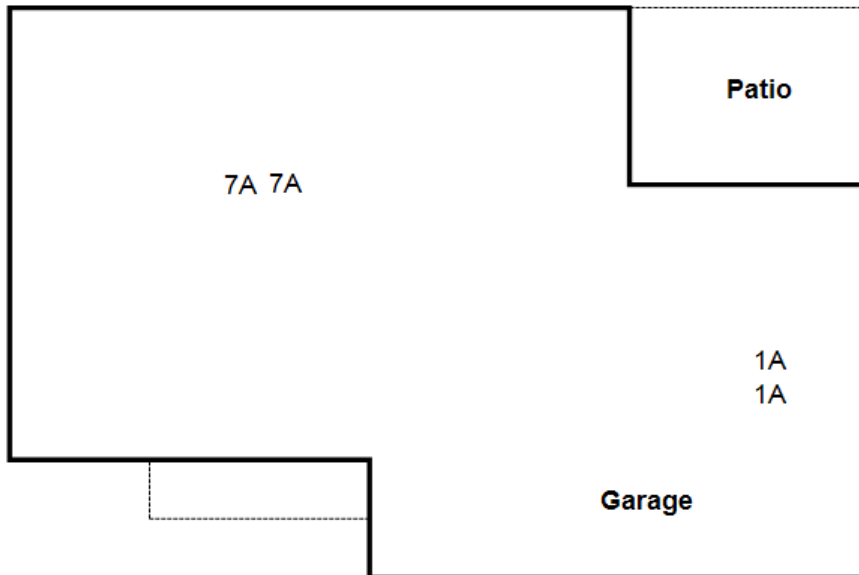
This Diagram is not to scale

FINDINGS: Evidence of subterranean termite infestations at substructure

FINDINGS: Evidence of drywood termite infestations at attic space

RECOMMENDATION: Pressure "ROD" treat, trench application or low pressure spot spray as necessary.  
Break accessible sub tubes.

RECOMMENDATION: Chemically treat visible and accessible infestations. Remove or cover accessible pellets.
